Manhole Inspection Summary

Manhole # S13AA2012MH

Insp Date: **7/25/06 1:08 PM**

Location Address: **5609 CROSS COUNTRY BLVD**

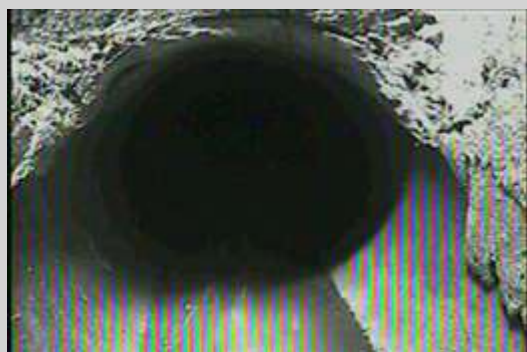
Pipe Out @ 12 O'Clock

10 in. Circular Gravity Sewer

Rod and Bar (Angled)

Pipe Material: **Clay** ☐ Pipe Lined

Infiltration: **None** Pipe Seal Cond: **Unknown**
